The Villas at Fairloop Run Association, Inc.

Subject: Roof Inspection Report

The Villas at Fairloop Run
Fairloop Run
Lehigh Acres, Lee County, Florida
Velocity Project Number: 19-413

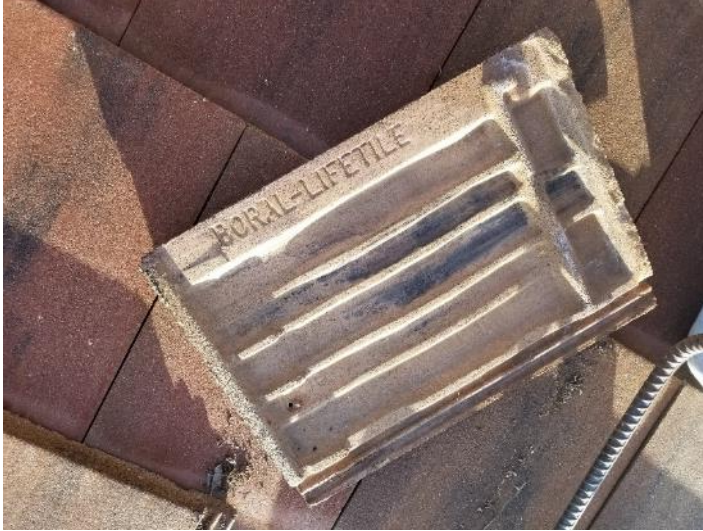
Photo 1: Existing tile – Boral Lifetile

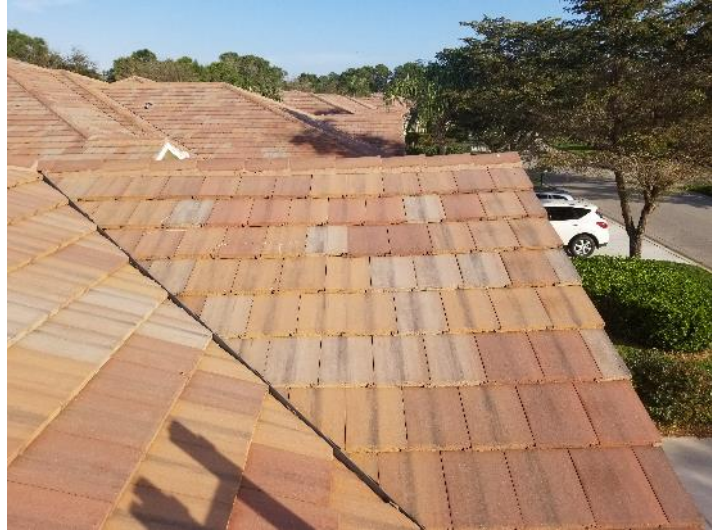
Photo 2: General view of roof on Bldg 1

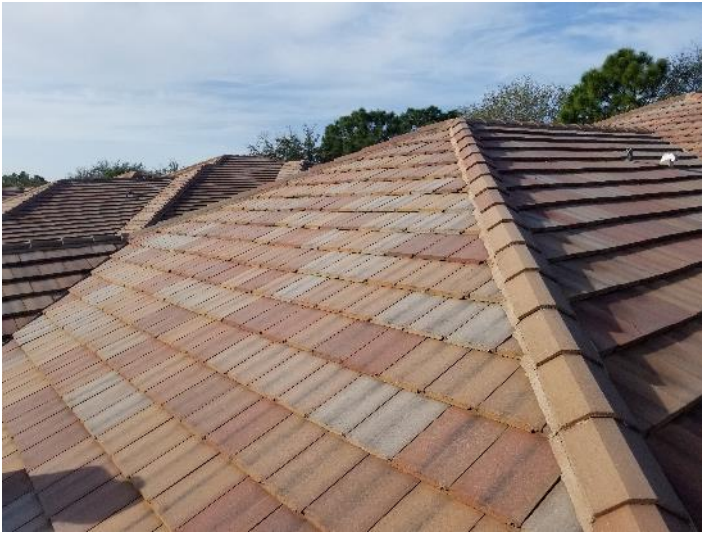
Photo 3: General view of roof at Bldg 5

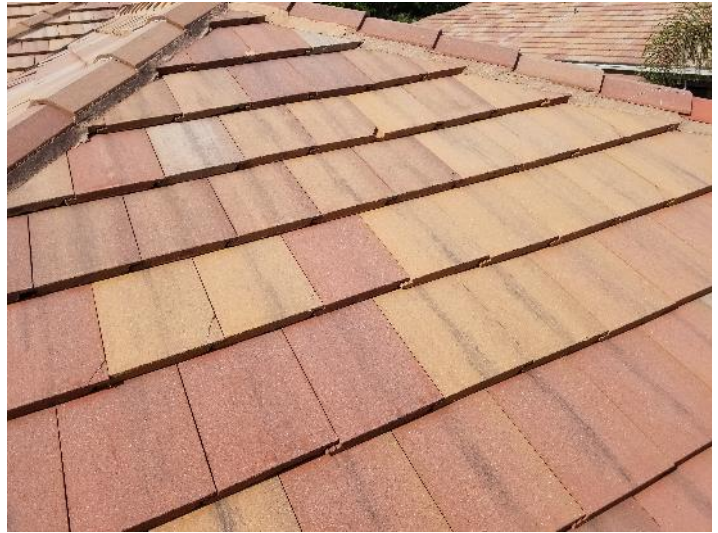
- ✓ Cracked tile including corner and horizontal cracks (Photo 4 through 6).
 - The corner of the tile is typically the most susceptible to cracking as this is the thinnest portion of the tile. During a high velocity wind events, such as Hurricane Irma, lifting of the tile, can cause this pattern of cracking. This condition was observed in all roofs.

- Horizontal cracks can be an indication of a point load being applied to the tile. Generally, this deficiency is caused by foot traffic. This condition was observed at isolated areas in all roofs.

Photo 4: Tile cracking at Bldg 13

Based upon Velocity's visual inspection, storm related damage caused by Hurricane Irma was observed on all building roofs. However, the damage did not appear to exceed 25 percent of the roof area of each building. Therefore, Velocity recommends that repairs be performed to the villa buildings through the Association to prevent further deterioration.

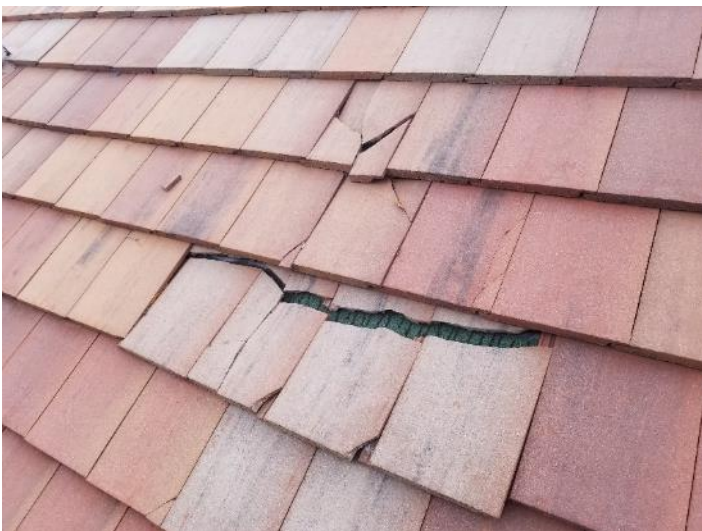
Photo 5: Tile cracking at Bldg 23

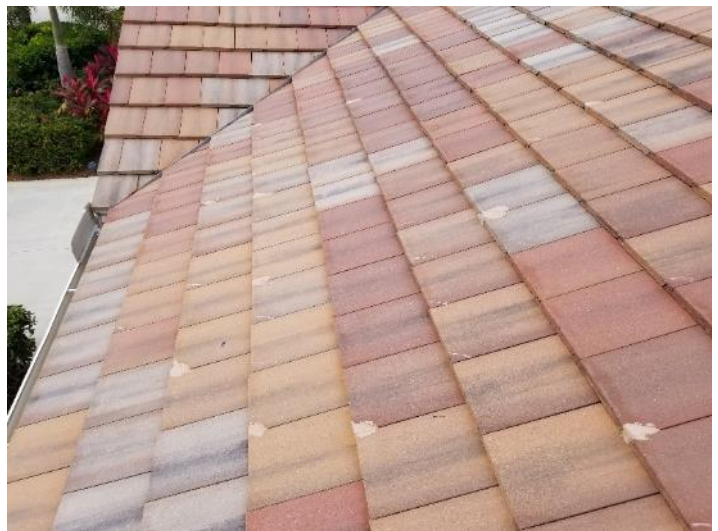
Photo 6: Tile cracking at Bldg 33

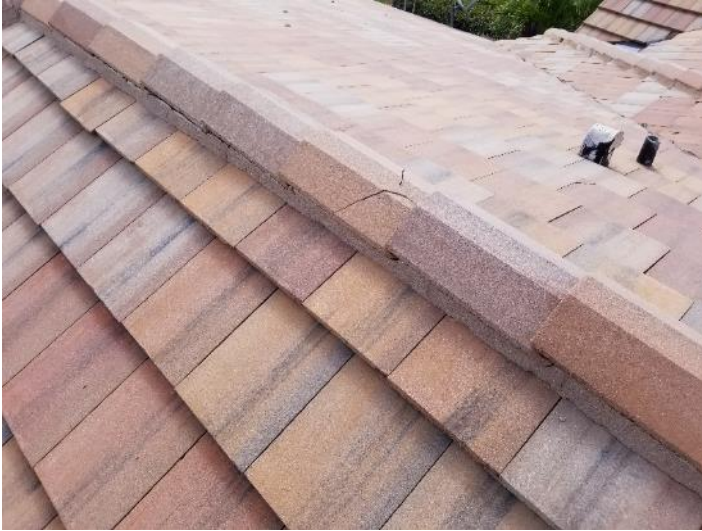
- ✓ Cracked and/or detached ridge and hip tile (Photo 7 through 10)
 - Detached and/or loose ridge tile was observed throughout the villa buildings at various locations.

Photo 7: Cracked ridge tile at Bldg 7

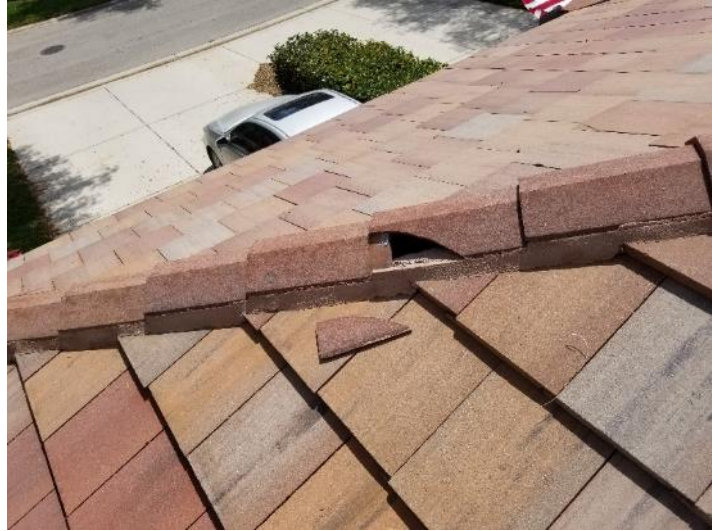
Photo 8: Cracked hip tile at Bldg 4

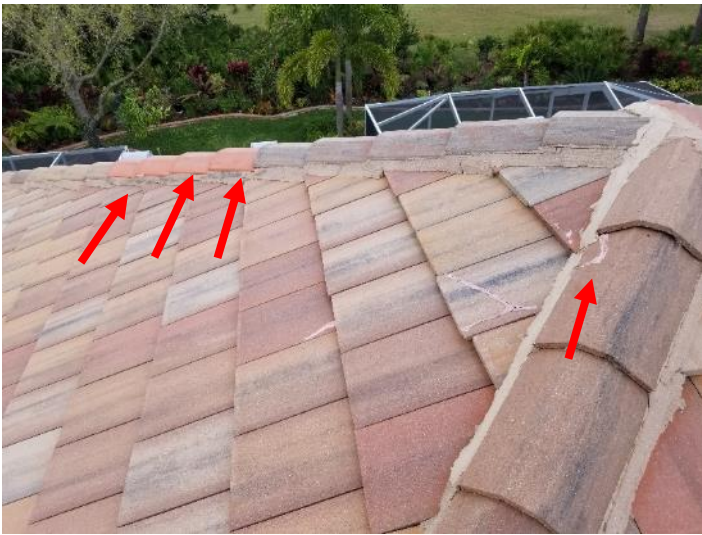
Photo 9: Cracked and mismatching hip tile at Bldg 10

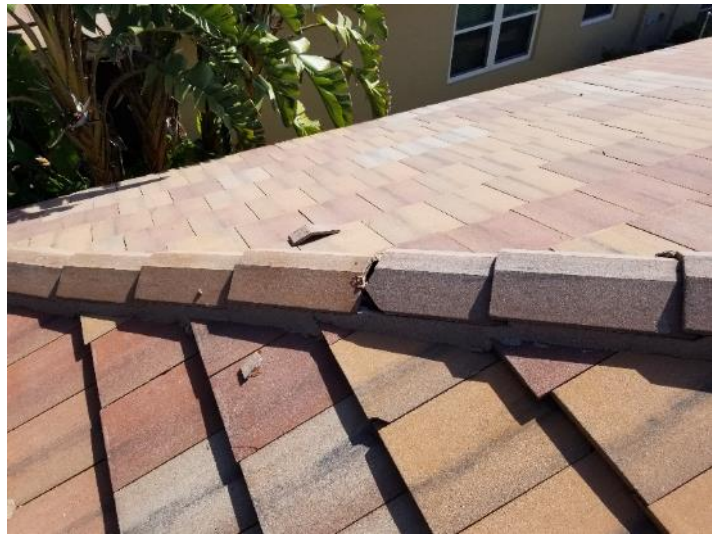
Photo 10: Cracked hip tile at Bldg 14

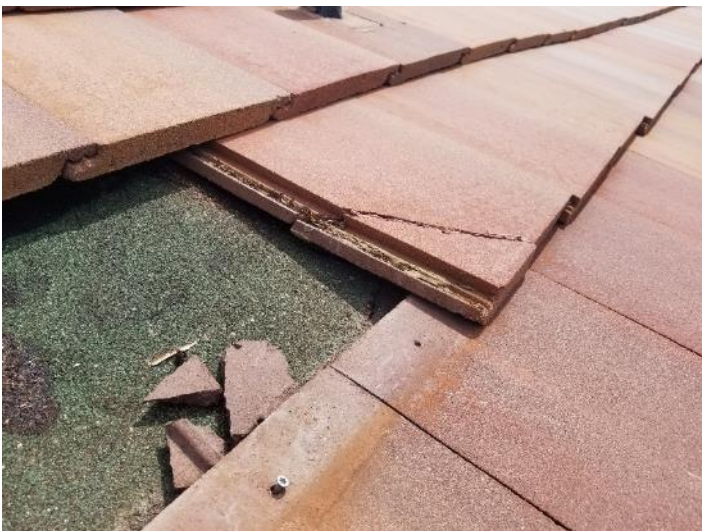
- Widespread cracked mortar was observed along the ridge and hip tile in all roofs.
- ✓ Tile uplift causing withdrawn fastener (Photo 11 through 14).
 - Withdrawn fastener (screws) and the associated damage to the screw holes in the tile was observed at isolated areas at each villa building where tile was removed to facilitate the inspection. During high velocity wind events, such as Hurricane Irma, uplift forces can cause the nose of the tile to lift. This lifting motion can cause screw movement including backout. This screw movement can compromise future uplift resistance, can increase the potential for water intrusion directly around the fastener penetration, and can cause damage to the underlayment. It is important to note that at some withdrawn fastener locations, Velocity was unable to determine if the fastener was withdrawn or if the screw head was never properly driven down during initial installation.

Photo 11: Fastener withdrawn & cracked tile at Bldg 21

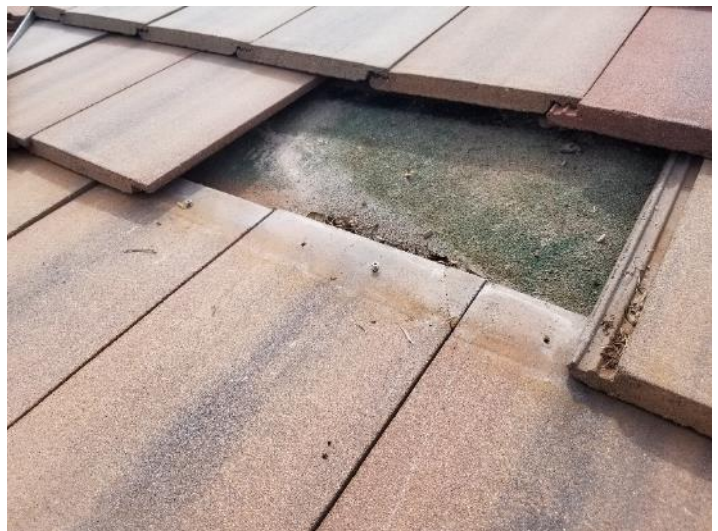
Photo 12: Fastener withdrawn & cracked tile at Bldg 27

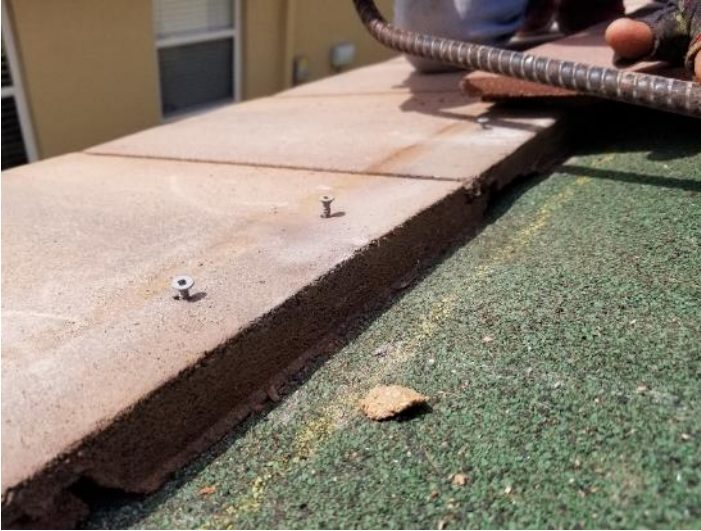
Photo 13: Fastener withdrawn & damage to fastener hole at Bldg 27

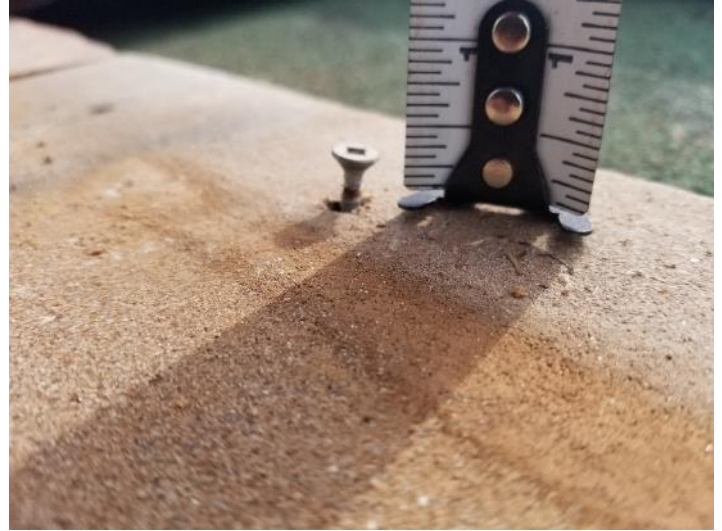
Photo 14: Fastener withdrawn & damage to fastener hole at Bldg 30

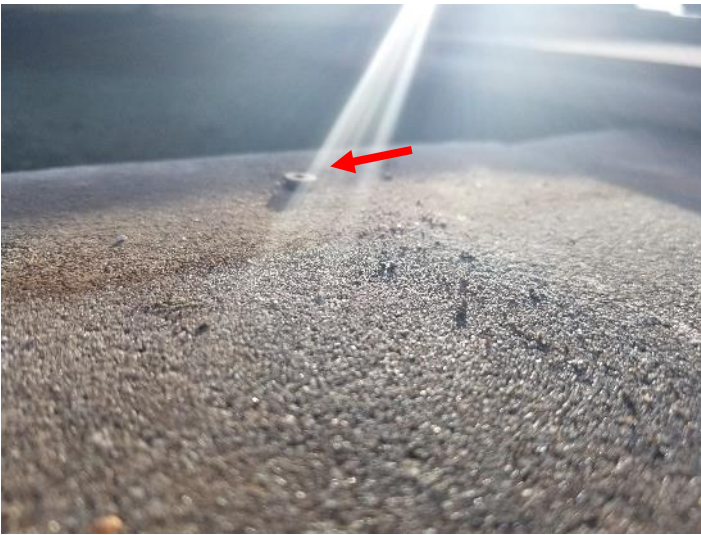
- At some locations observed, the fasteners appeared to be in the original installed location indicating that fastener withdrawal was isolated (Photo 15).

Photo 15: Fastener that doesn't appear withdrawn at Bldg 1

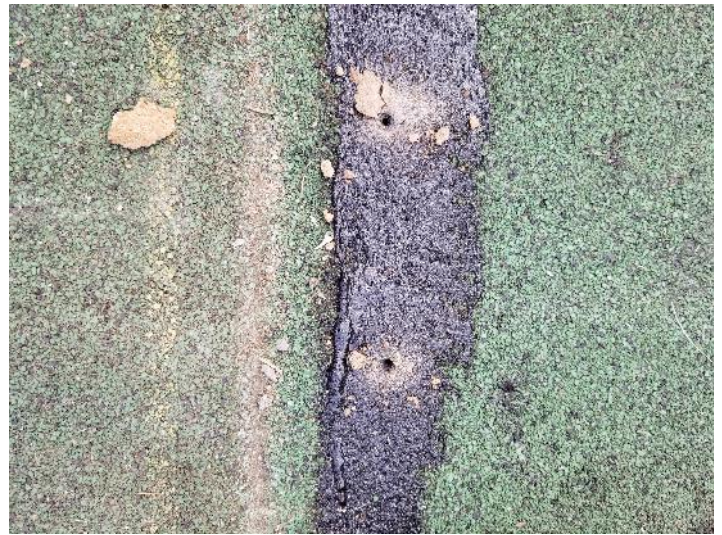
- Where observed the roof underlayment appears to be in fair condition, consistent with its age. At isolated areas, damage to the underlayment caused by fastener withdrawn and movement was observed.

Photo 16: Undamaged underlayment at removed tile on Bldg 27

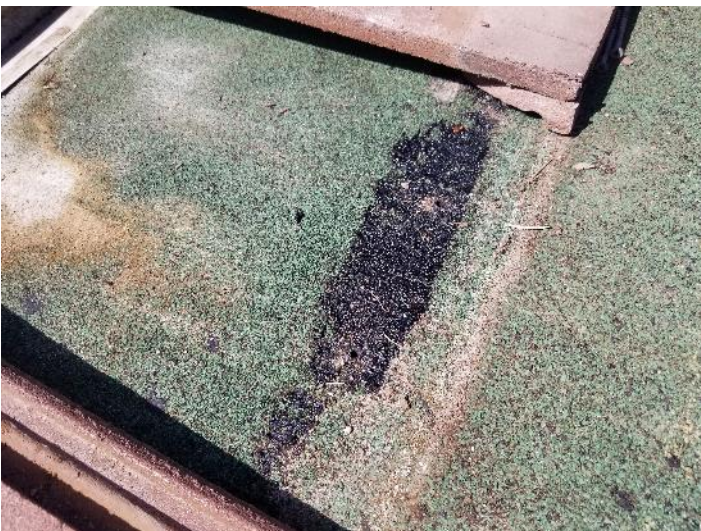
Photo 17: Undamaged underlayment at removed tile on at Bldg 11

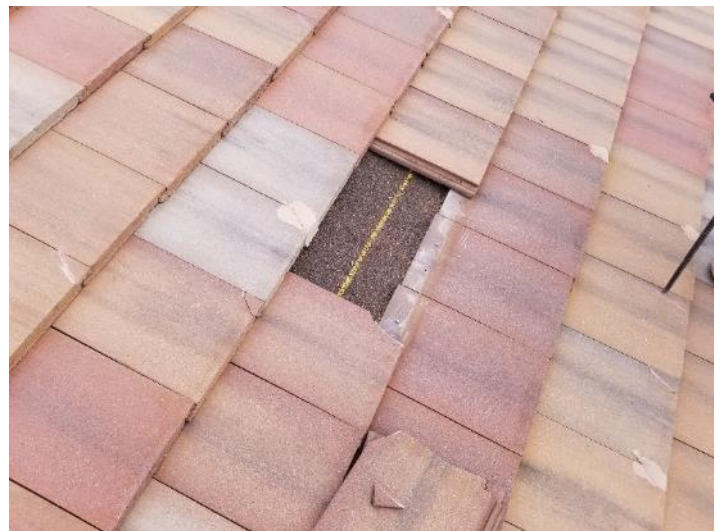
Photo 18: Cracked tile adjacent to withdrawn fasteners at Bldg 33

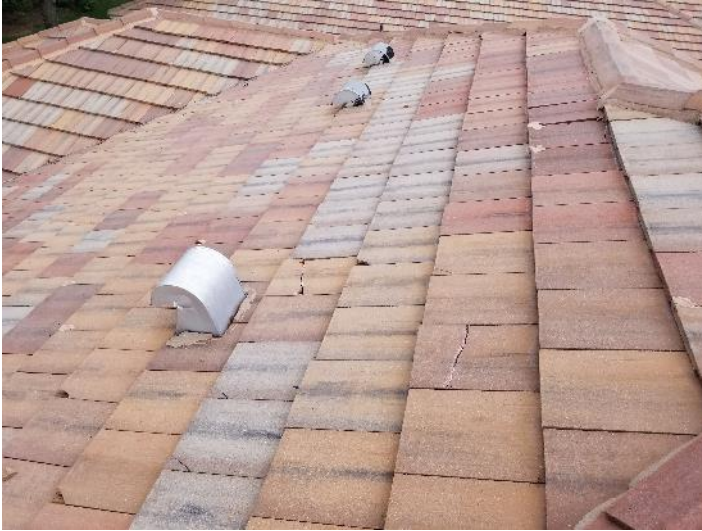
- Areas of tile movement/shifting were observed throughout all buildings. This movement/shifting was visually observed and also noticed when walking across the roof. This resulting movement can disturb tile interlocking and water shedding ability.

Photo 19: Cracked and shifted tile at Bldg 13

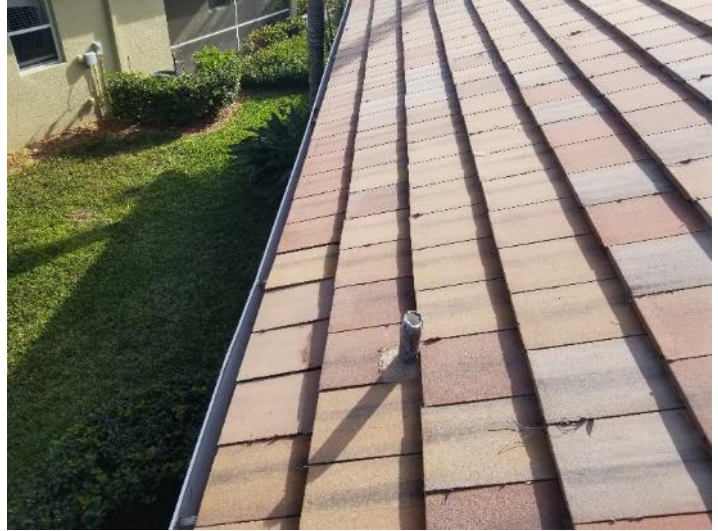
Photo 20: Shifted tile at Bldg 5

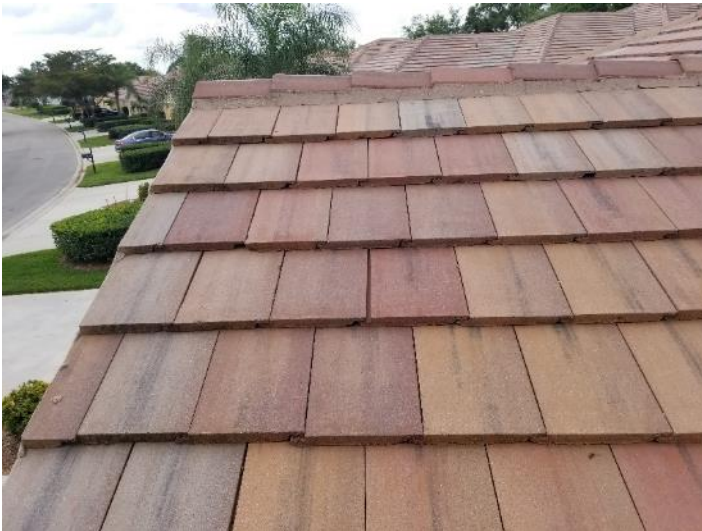
Photo 21: Tile shifting at Bldg 6

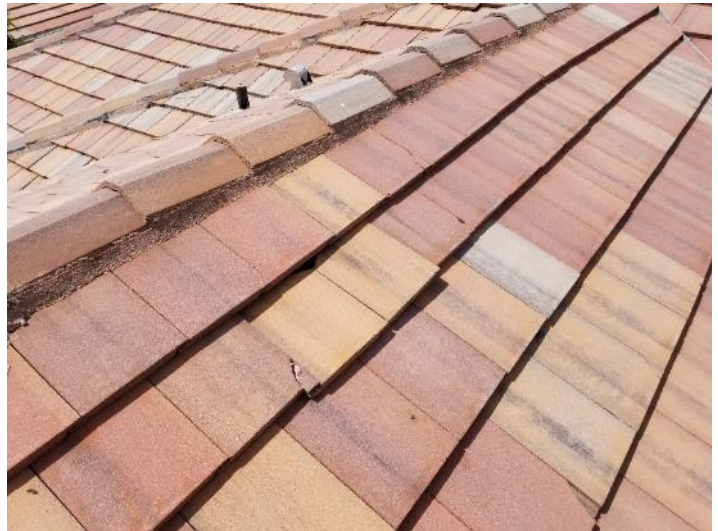
Photo 22: Tile shifting at Bldg 8

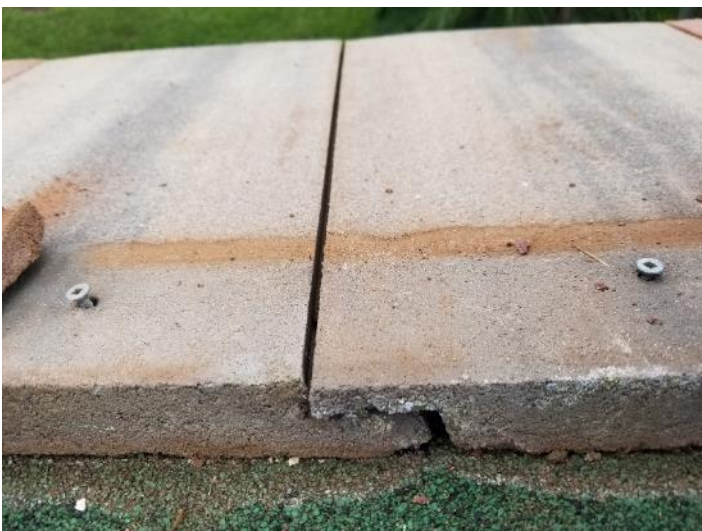
Photo 23: Tile shifting at withdrawn fastener locations at Bldg 30

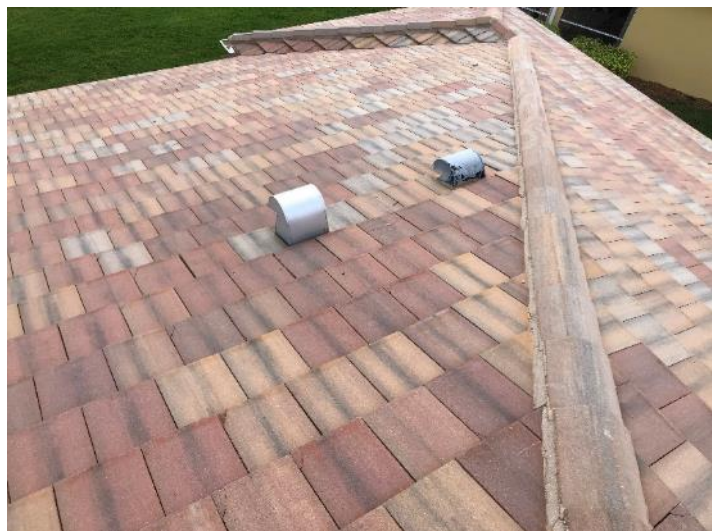
Photo 24: Tile shifting at Bldg 31
